NACA RM E51G13

RELATION OF ENGINE TURBINE-BLADE LIFE TO STRESS-RUPTURE
PROPERTIES OF THE ALLOYS, STELLITE 21, HASTELLOY B, CAST

S-816, FORGED S-816, X-40, NIMONIC 80, REFRACTALLOY 26,
N-155, AND INCONEL X

By F. B. Garrett and C. Yaker

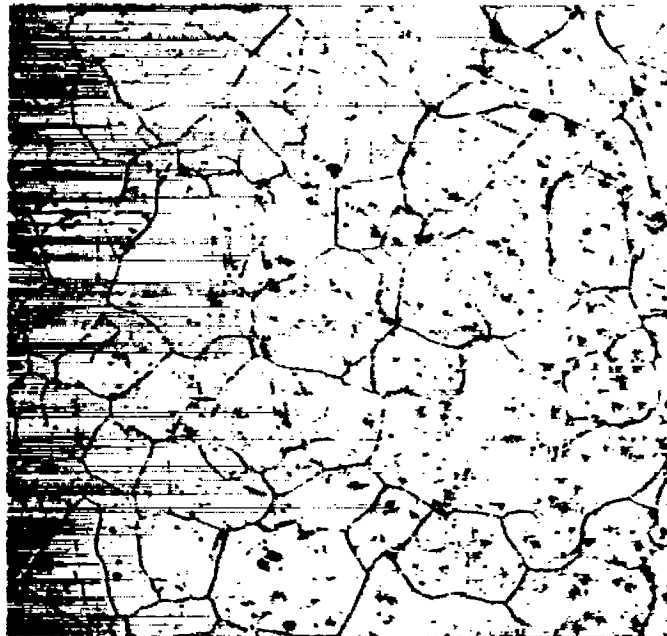
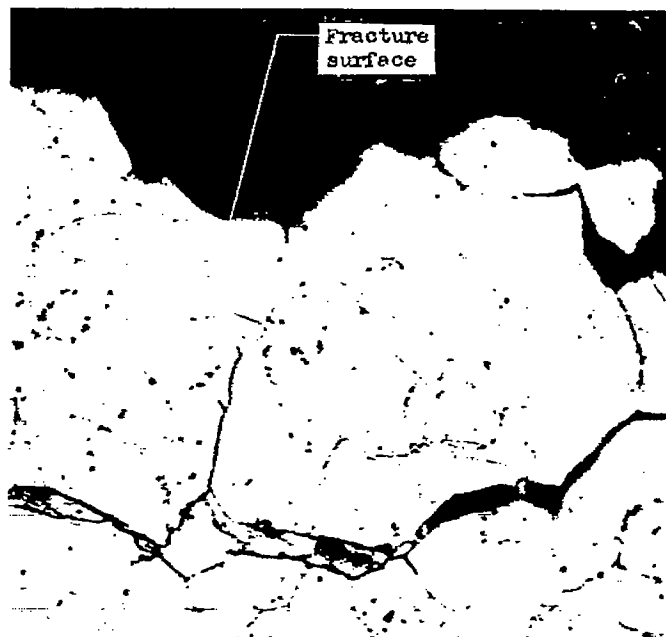
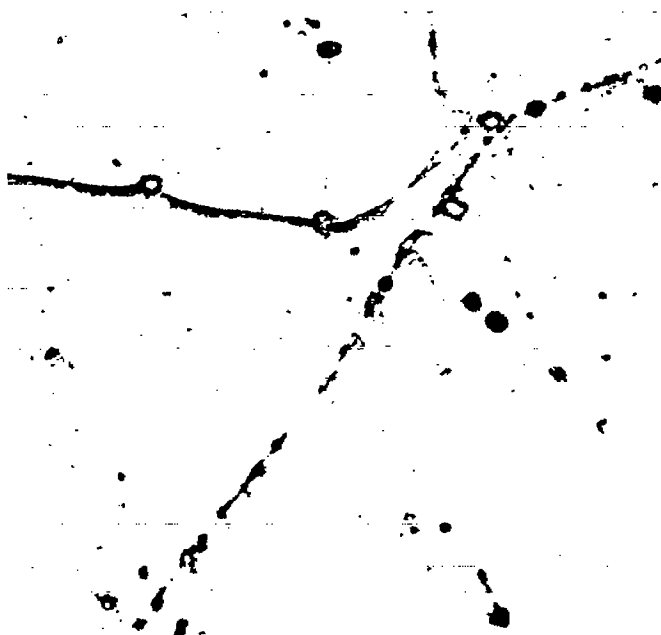
(a) Initial blade failure.

(b) Typical blade failure.

Figure 13. - Results of metallurgical examination of Refractaloy 26 blades.

(c) Grain size throughout blade, A.S.T.M. 2 to 3. Electrolytically etched in 10-percent chromic acid; X100; oblique illumination.

(d) Nature of fracture propagation. Electrolytically etched in 10-percent chromic acid; X150.

(e) Structure before operation. Electrolytically etched in 10-percent chromic acid; X1000.

(f) Structure after operation. Electrolytically etched in 10-percent chromic acid; X1000.

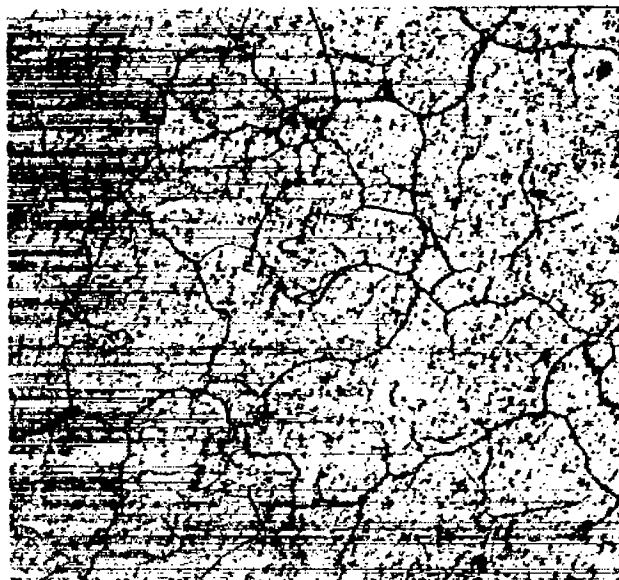
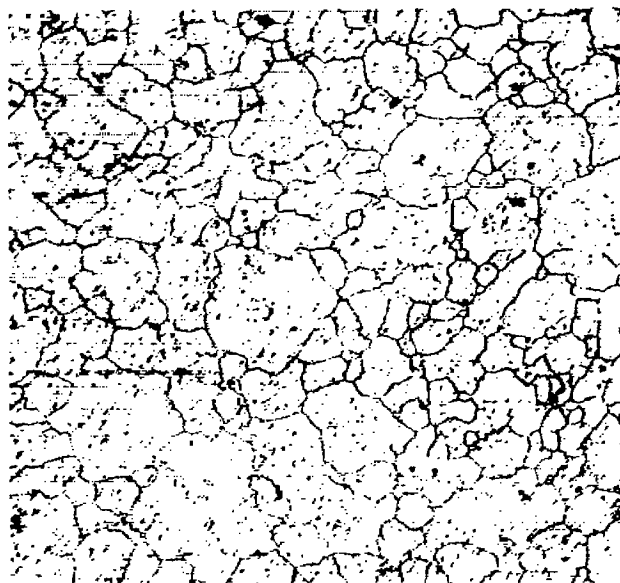
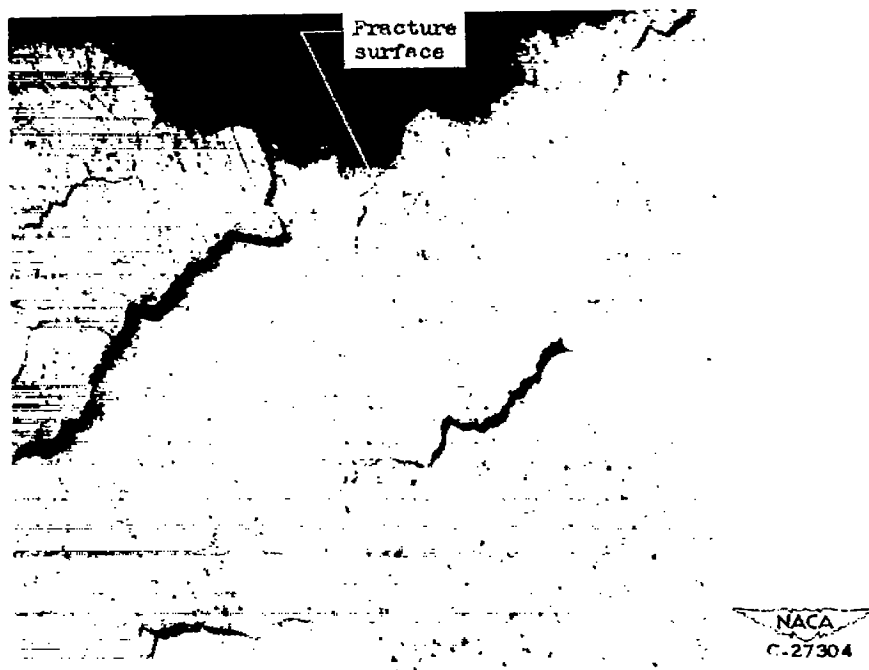
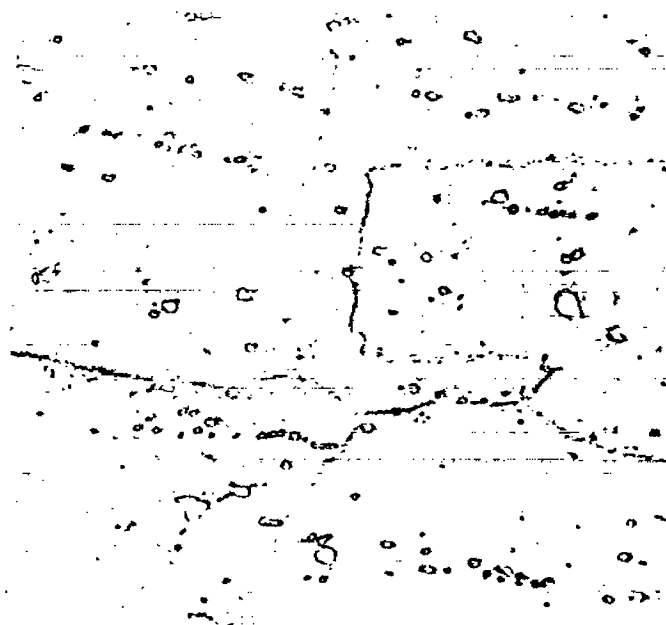
(a) Beginning of failure.

(b) Typical failure.

Figure 14. - Results of metallurgical examination of N-155 blades.

Center of blade, A.S.T.M. 2 to 4.

Edges of blade, A.S.T.M. 3 to 5.

(c) Grain size. Electrolytically etched
in 10-percent chromic acid; X100.

(d) Intercrystalline fracture and cracking.
Electrolytically etched in 10-percent
chromic acid; X100.

(e) Structure before operation. Electrolytically etched in 10-percent chromic acid; X100.

(f) Structure after operation. Electrolytically etched in 10-percent chromic acid; X1000.

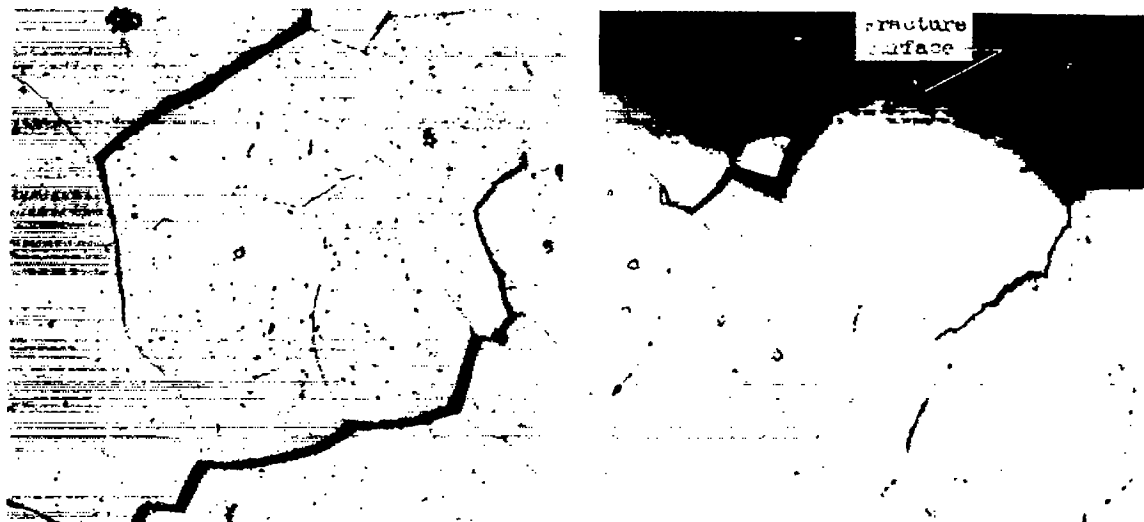
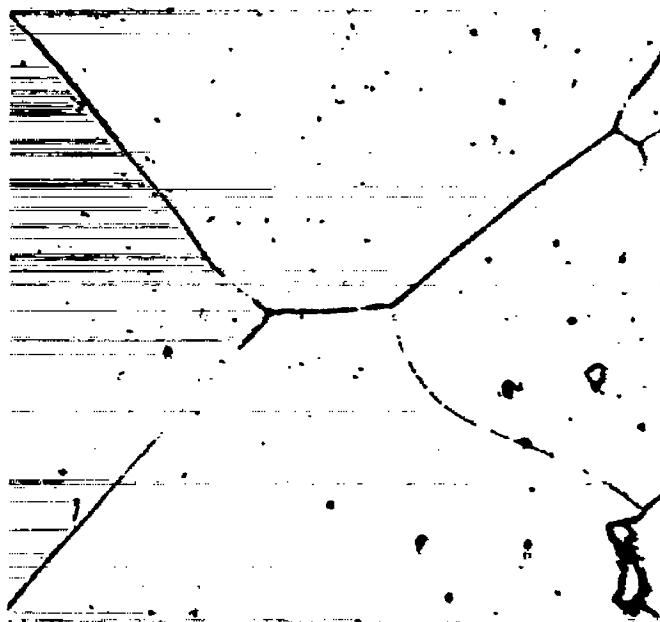
(a) Typical blade failure.

Figure 15. - Results of metallurgical examination of Inconel X.

(b) Grain size throughout blades, A.S.T.M. 2 to 3. Electrolytically etched in 10-percent chromic acid; X100.

(c) Intercrystalline fracture and cracking. Electrolytically etched in 10-percent chromic acid; X250.

(d) Structure before operation. Electrolytically etched in 10-percent chromic acid; X1000.

(e) Structure after operation. Electrolytically etched in chromic acid, X1000.

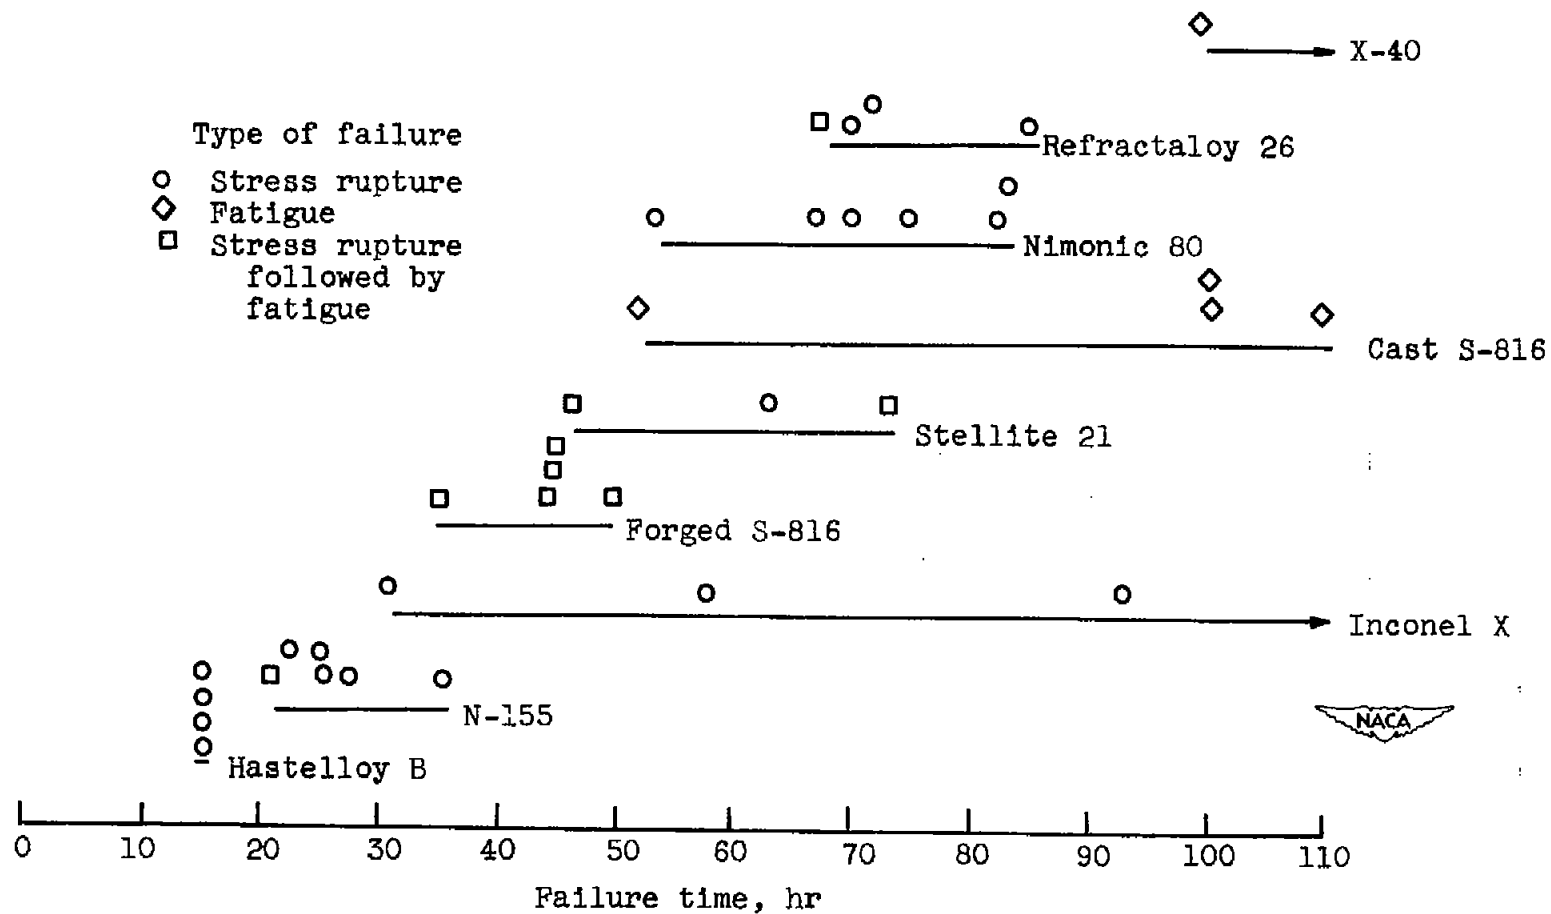
Figure 16. - Classification of true blade failures.

The results of the metallurgical examination are presented in figures 8 to 16, which present the nature of the blade failures on a macroscopic and microscopic scale, the changes in structure during operation, and for the forged alloys, the grain size of the blades. No metallurgical examination of the Hastelloy B blades is included in this report because the nature of the blade failures and structural changes are the same as those described in reference 5. In all cases the microphotographs shown are those believed typical of the entire blade sample both as to nature of failure and structure before and after operation. The results of the metallurgical examinations of the blade failures indicate that the failures were of the following three types:

The preceding classifications refer only to the beginning zones of blade failure. After fracture has progressed to a critical depth by any of the foregoing types of failure, the blades fail in tension because of the high stresses produced by the reduced load-carrying area. In figure 16, the results of the engine operation are presented showing the type of failure mechanism associated with each true blade failure (failure initiated by mechanical damage is considered not a true blade failure). Some confirmation of the accuracy of the failure classifications will be found in the comparison of the results of the engine and stress-rupture tests presented later in this report. Metallurgical examination of the blades did not indicate any significant differences in structure between the first and last blades of each alloy to fail.

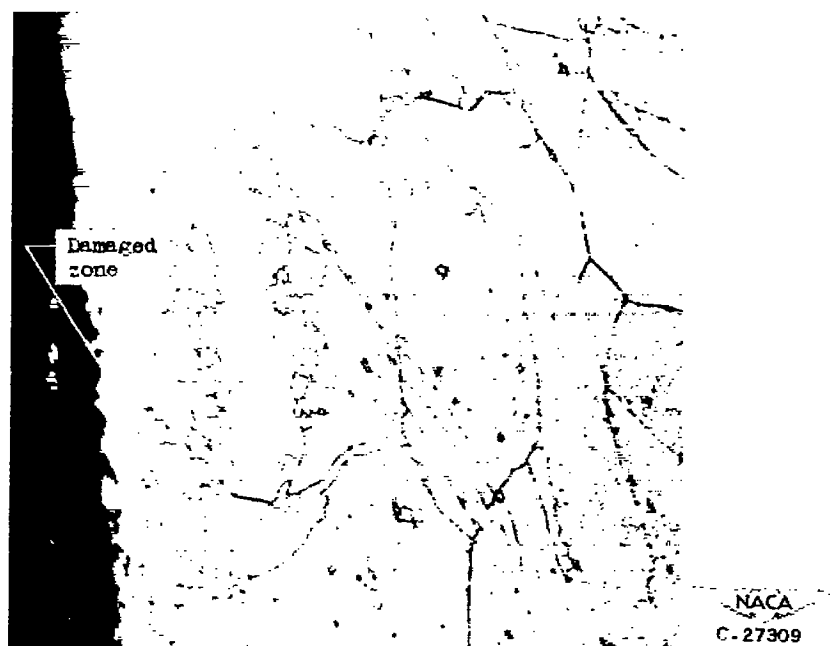
Figure 17. - Recrystallization as result of overheating at zone of damage in Inconel X blades. Electrolytically etched in 10-percent chromic acid; X250.

No comparison could be made between the structures of the previously fractured blades and the blades still in operation at the conclusion of the investigation. The remaining blades were overheated in the engine failure that ended the test. This is evidenced by the recrystallization at the zone of damage in an Inconel X blade (fig. 17).

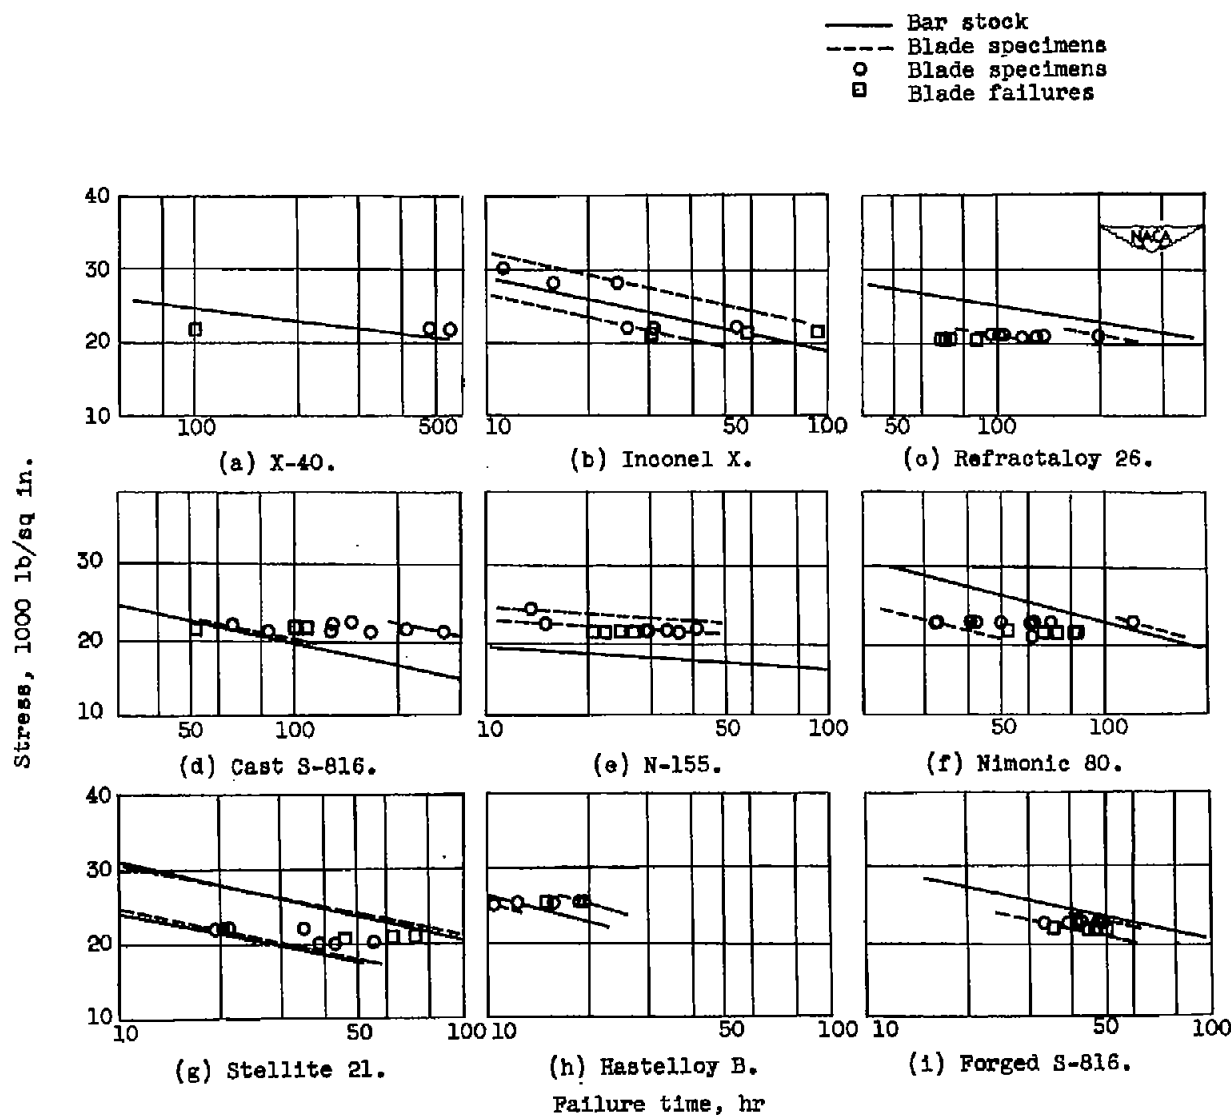
Figure 18. - Comparison of results of stress-rupture and engine investigation.

2169 The results of the stress-rupture tests from blade specimens and blade life in the engine are compared in figure 18. The blade-failure times are plotted at the average stress levels shown in table II. Included in figure 18 are the stress-rupture curves for bar stock of the same lots (reference 6) from which the blades were fabricated for all alloys except Stellite 21 and Hastelloy B. For these two alloys, the manufacturer's data were used. For the cast alloys, the strength of the blades is nearly equal to or just above that of the bar stock. The slight strength differences between the cast bar stock and the blades was probably due to the heat-treating of the bars, whereas the blade specimens were tested in the as-cast condition. For the forged alloys, the strength of the blades is below that of the bar stock for the alloys, S-816, Nimonic 80, and Refractaloy 26, approximately equal to the bar stock for Inconel X and Hastelloy B, and above that of the bar stock for only N-155. These results indicate that only the N-155 has been improved by forging into blades. The results of the blade failures in the engine fall within the bands drawn through results of the blade-specimen stress tests for the alloys, Stellite 21, Hastelloy B, forged S-816, Nimonic 80, and Inconel X. For cast S-816, X-40, Refractaloy 26, and N-155, some or all the blade failures fall below the bands for the blade specimens.

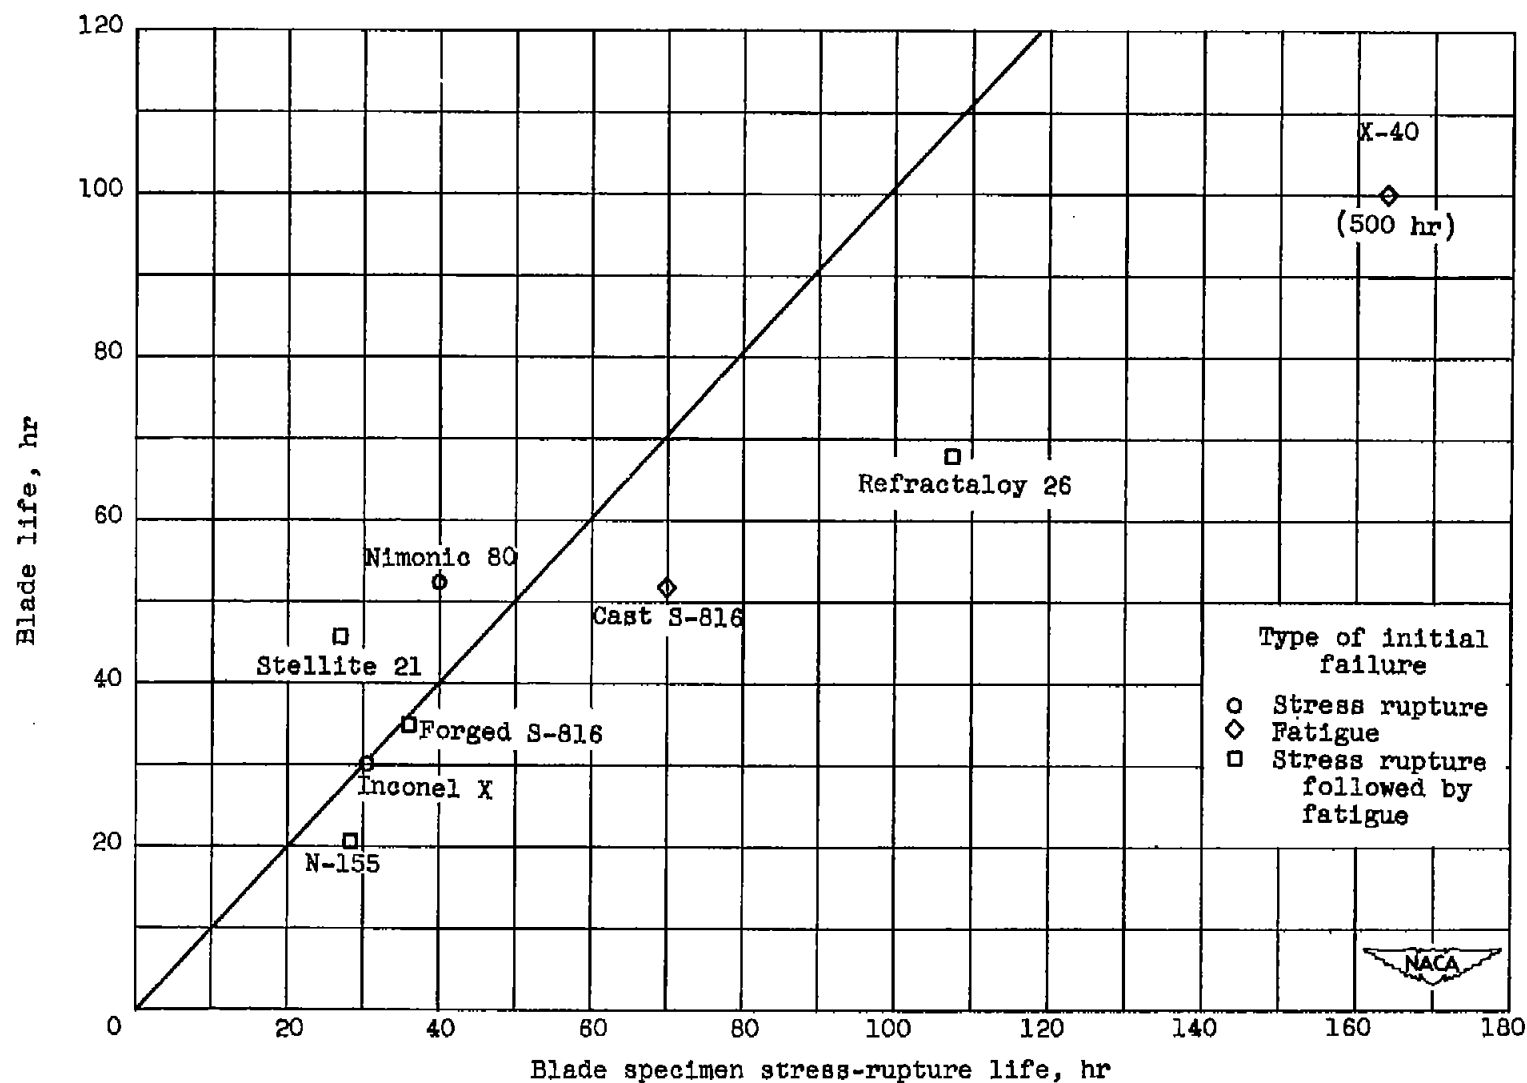
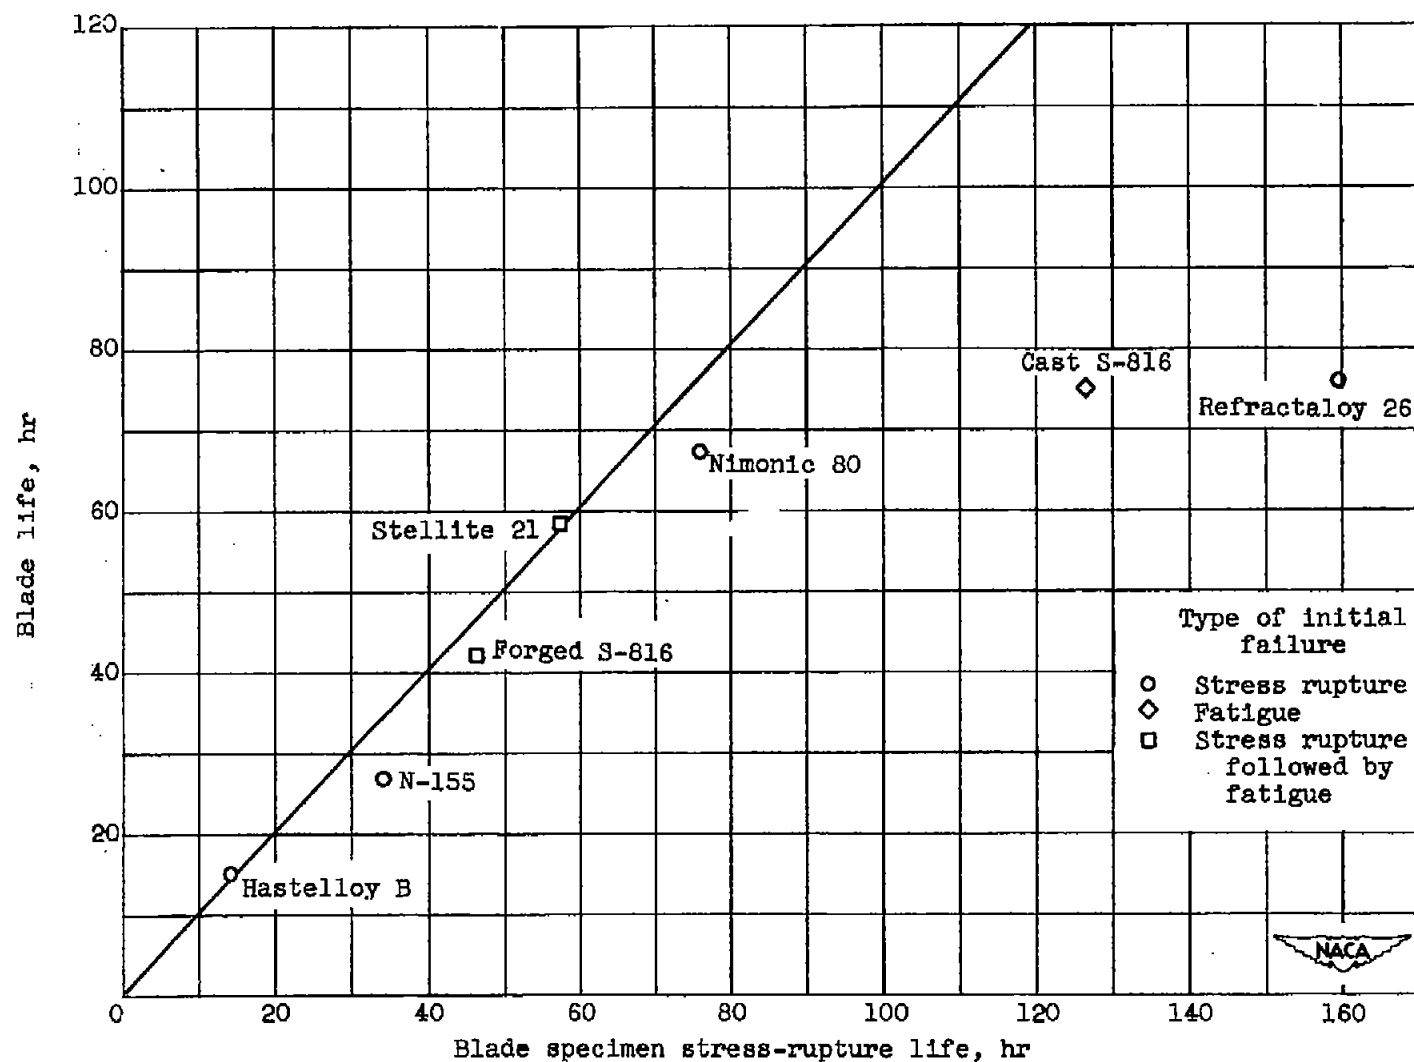
(a) Based on minimum life.

Figure 19. - Relation of blade life to stress-rupture life.

(b) Based on average data taken at midpoint of failure band.

In figure 19, the stress-rupture life of the blades as determined from blade specimens is compared with the blade life in the engine. In figure 19(a), the comparison is made on the basis of the minimum blade life and the minimum stress-rupture life; also the data points are classified as to type of initial blade failure encountered. There is no minimum point for Hastelloy B because all failures occurred at the same time and are plotted as an average point in a later figure. This curve indicates that for the alloys, N-155, Inconel X, forged S-816, Stellite 21, and Nimonic 80, the minimum blade life can be predicted with a fair degree of accuracy from stress-rupture tests on blade specimens. The Stellite 21 and Nimonic 80 points lie above the line of 1:1 correlation, indicating higher minimum blade life than that predicted by the stress-rupture tests. This anomaly is probably the result of both the relatively small sample, which did not accurately define the minimum blade life and, in the case of Stellite 21, the grain-orientation effect in the blade specimen. The three alloys that had significantly lower minimum blade life than that predicted by the blade-specimen stress rupture were cast S-816, Refractaloy 26, and X-40.

The average blade life is compared with the average blade-specimen stress-rupture life in figure 19(b). The failure types for each alloy shown in figure 19(b) are those most characteristic of that alloy. In

this case, the alloys, Hastelloy B, N-155, forged S-816, Stellite 21, and Nimonic 80, conform to the line of 1:1 correlation, whereas the alloys, cast S-816 and Refractaloy 26, fall considerably below the line. No average points were plotted for Inconel X and X-40 because some of the blades of these alloys were still intact at the conclusion of the engine investigation. From these two plots (fig. 19) discounting the high minimum blade life of the Stellite 21 and Nimonic 80, prediction of blade life with accuracy could be made on the basis of the stress-rupture strength of the blades for the alloys of relatively low blade-specimen strength (short life (fig. 18)), that is, Hastelloy B, N-155, Inconel X, forged S-816, Stellite 21, and Nimonic 80. The vibration and cyclic operation apparently do not decrease the life of these alloys. These results also confirm the classification of the failure types for these alloys because they were all either of the stress-rupture or stress-rupture-followed-by-fatigue type. In reference to the stress-rupture-followed-by-fatigue-type failure, the results indicate that the fatigue mechanism only propagates the fracture of the alloys after the start as the result of the stress-rupture-type failure. The alloys that had blade lives appreciably lower than those predicted by the stress-rupture tests of the blade specimens were the relatively higher blade-specimen strength (short life (fig. 18)) alloys, cast S-816, X-40, and Refractaloy 26. For the cast S-816, and X-40, the low blade life can be explained by the failure of these alloys through a fatigue-type fracture, which indicates that their blade life is shortened by vibratory stresses. The Refractaloy 26, however, is anomalous in that examination of the failures indicated that they apparently had the characteristics of a stress-rupture failure. A possible answer to why the Refractaloy 26 blades failed in less time than predicted by stress-rupture test can be found in the nature of the oxide film on the blades. In figure 20(a), a tightly adherent oxide film, which formed on the blades during engine operation, is visible. In figures 20(b) and 20(c), this same oxide film appears to be penetrating along the grain boundaries of the blade and is visible along the fracture surface of the blade. In the stress-rupture test, the oxide film, which is apparently quite adherent, probably penetrates into the grain boundary very slowly and the oxidation does not appreciably contribute to the failure of the alloy. Under the influence of vibratory stresses and the alternate heating and cooling in the engine, however, this tight oxide film would be broken by the reversal of stresses further exposing the surface of the metal so that penetration would proceed more rapidly with a resultant reduction in alloy strength (shorter life).

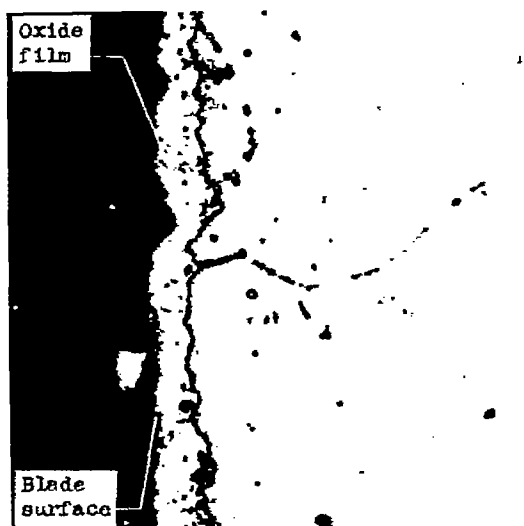
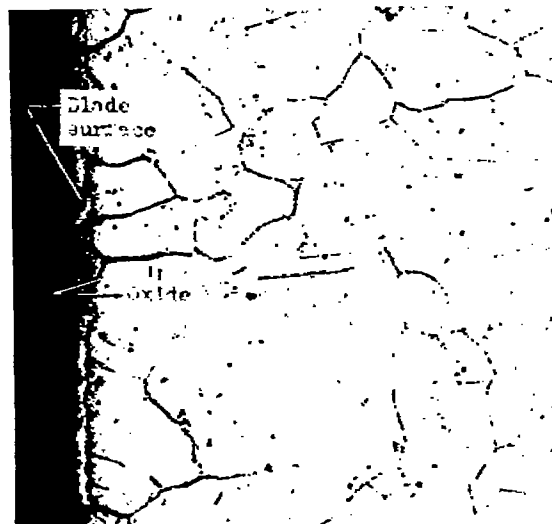
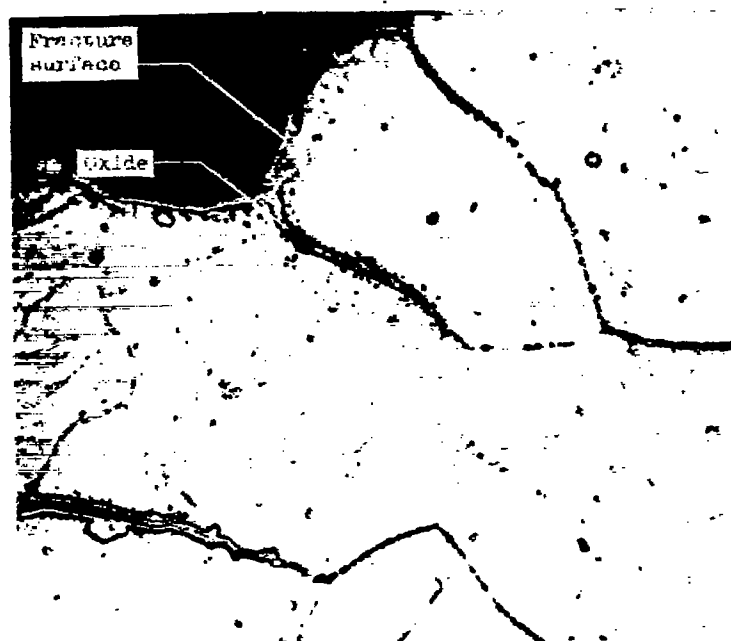
(a) Oxide film on blade surface; X250.

(b) Intergranular penetration of oxide on blade surface; X100.

(c) Oxide in grain boundaries and along fracture surface; X250.

Figure 20. - Oxide penetration of Refractaloy 26 during engine operation. Electrolytically etched in 10-percent chromic acid.

2. The engine life for the blades of the relatively high strength alloys, cast S-816, X-40 and Refractaloy 26, fell below the life predicted on the basis of the stress-rupture properties of the blades. In the case of the cast S-816 and X-40 blades, the low life was attributed to the influence of vibratory stresses in contributing to the failure of the blades. In the case of the Refractaloy 26 blades, the low life was attributed to corrosion accelerated by the vibratory and thermal stresses in the engine.
